Appendix A. Geotechnical Engineering Report

Site Reconnaissance and Construction Recommendations
for the Coos County Natural Gas Pipeline
Project

GEOTECHNICAL ENGINEERING REPORT
Route Reconnaissance and Construction Recommendations for the Coos
County Natural Gas Pipeline Project

DATE: November 28, 2001

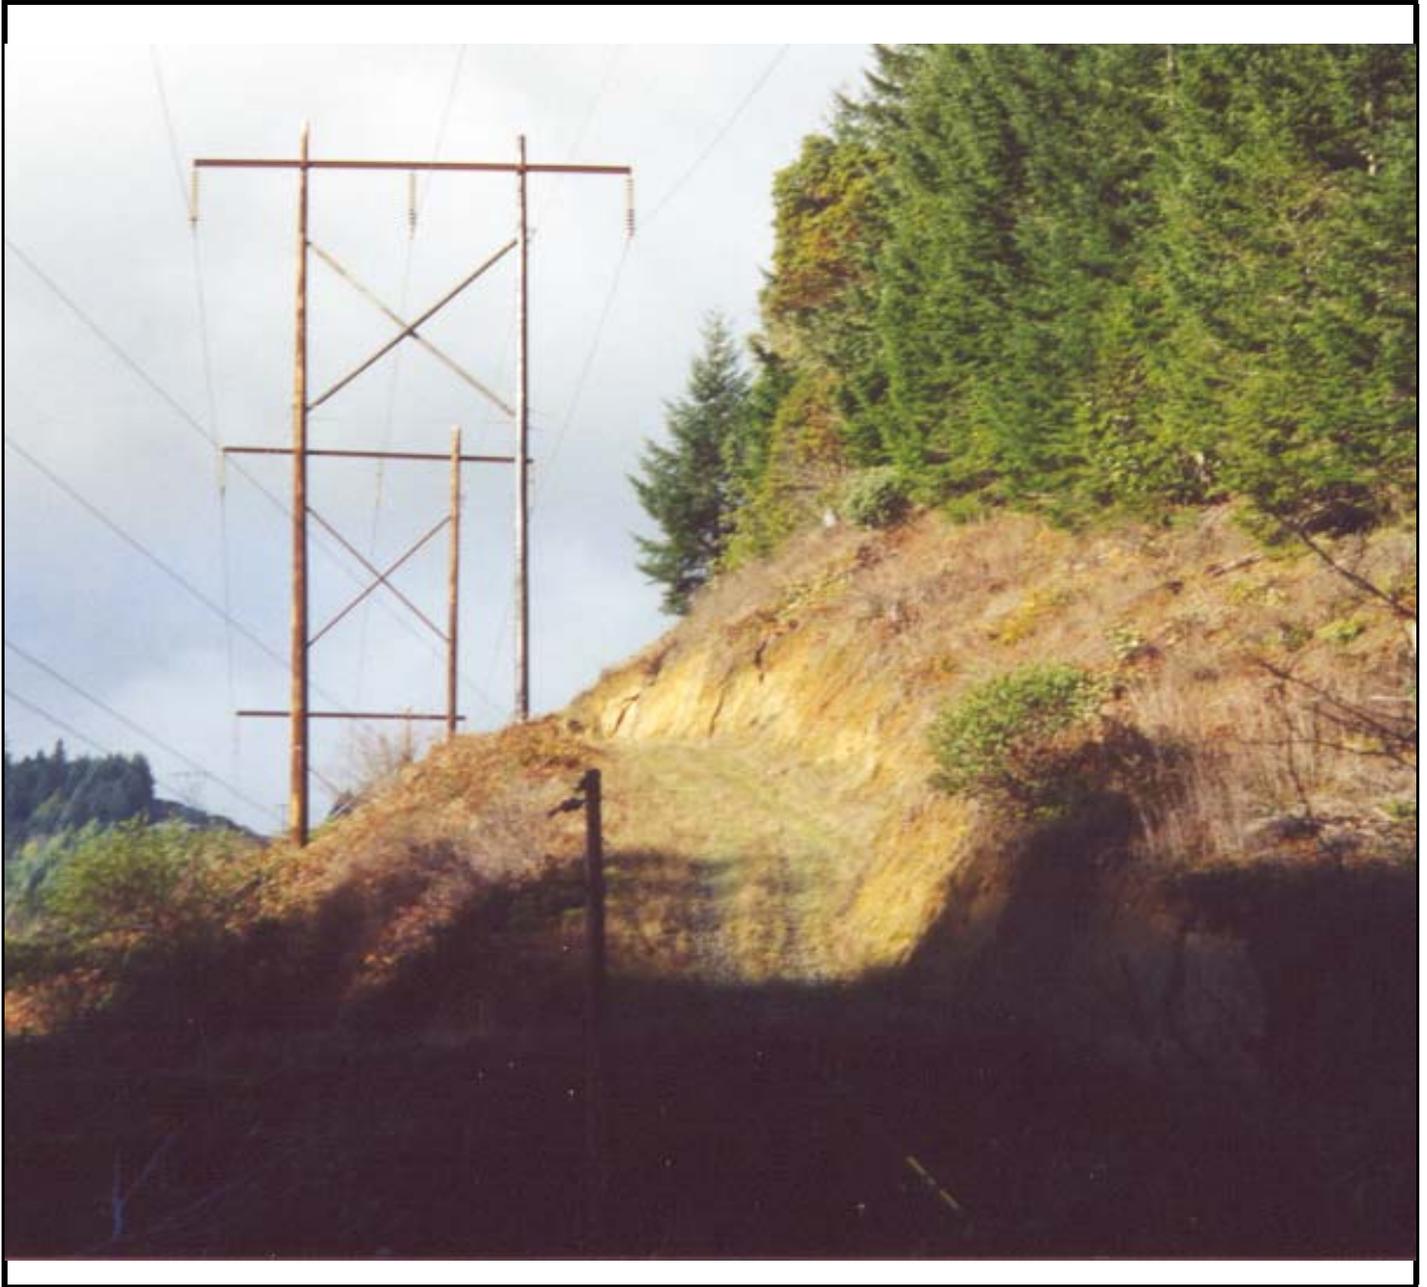
1. **Sideslope Construction.** Along several locations, the BPA power line was constructed on relatively steep sideslopes, illustrated by Figure A-2. Since pipeline construction equipment will require a reasonably level working space of 25 to 30 feet wide, as much as 60 feet in width will be required to allow excavation and leveling of the work area. Except for minor impacts on schedule, this feature does not present unusual complexity.
2. **Steepness of Slopes.** The heavily eroded ridge and valley ground surface along the route from Reston to Dora has resulted in very steep slopes with large elevation differences between the ridge top and valley bottom. Steep slopes reaching, and occasionally exceeding, 20 percent grade exist along the sections of the pipeline originally proposed to be placed in the BPA power line right-of-way. This is illustrated in Figure A-3.

Figure A-2. View of BPA powerline on steep hillside at Mile 10 on CBW Road.

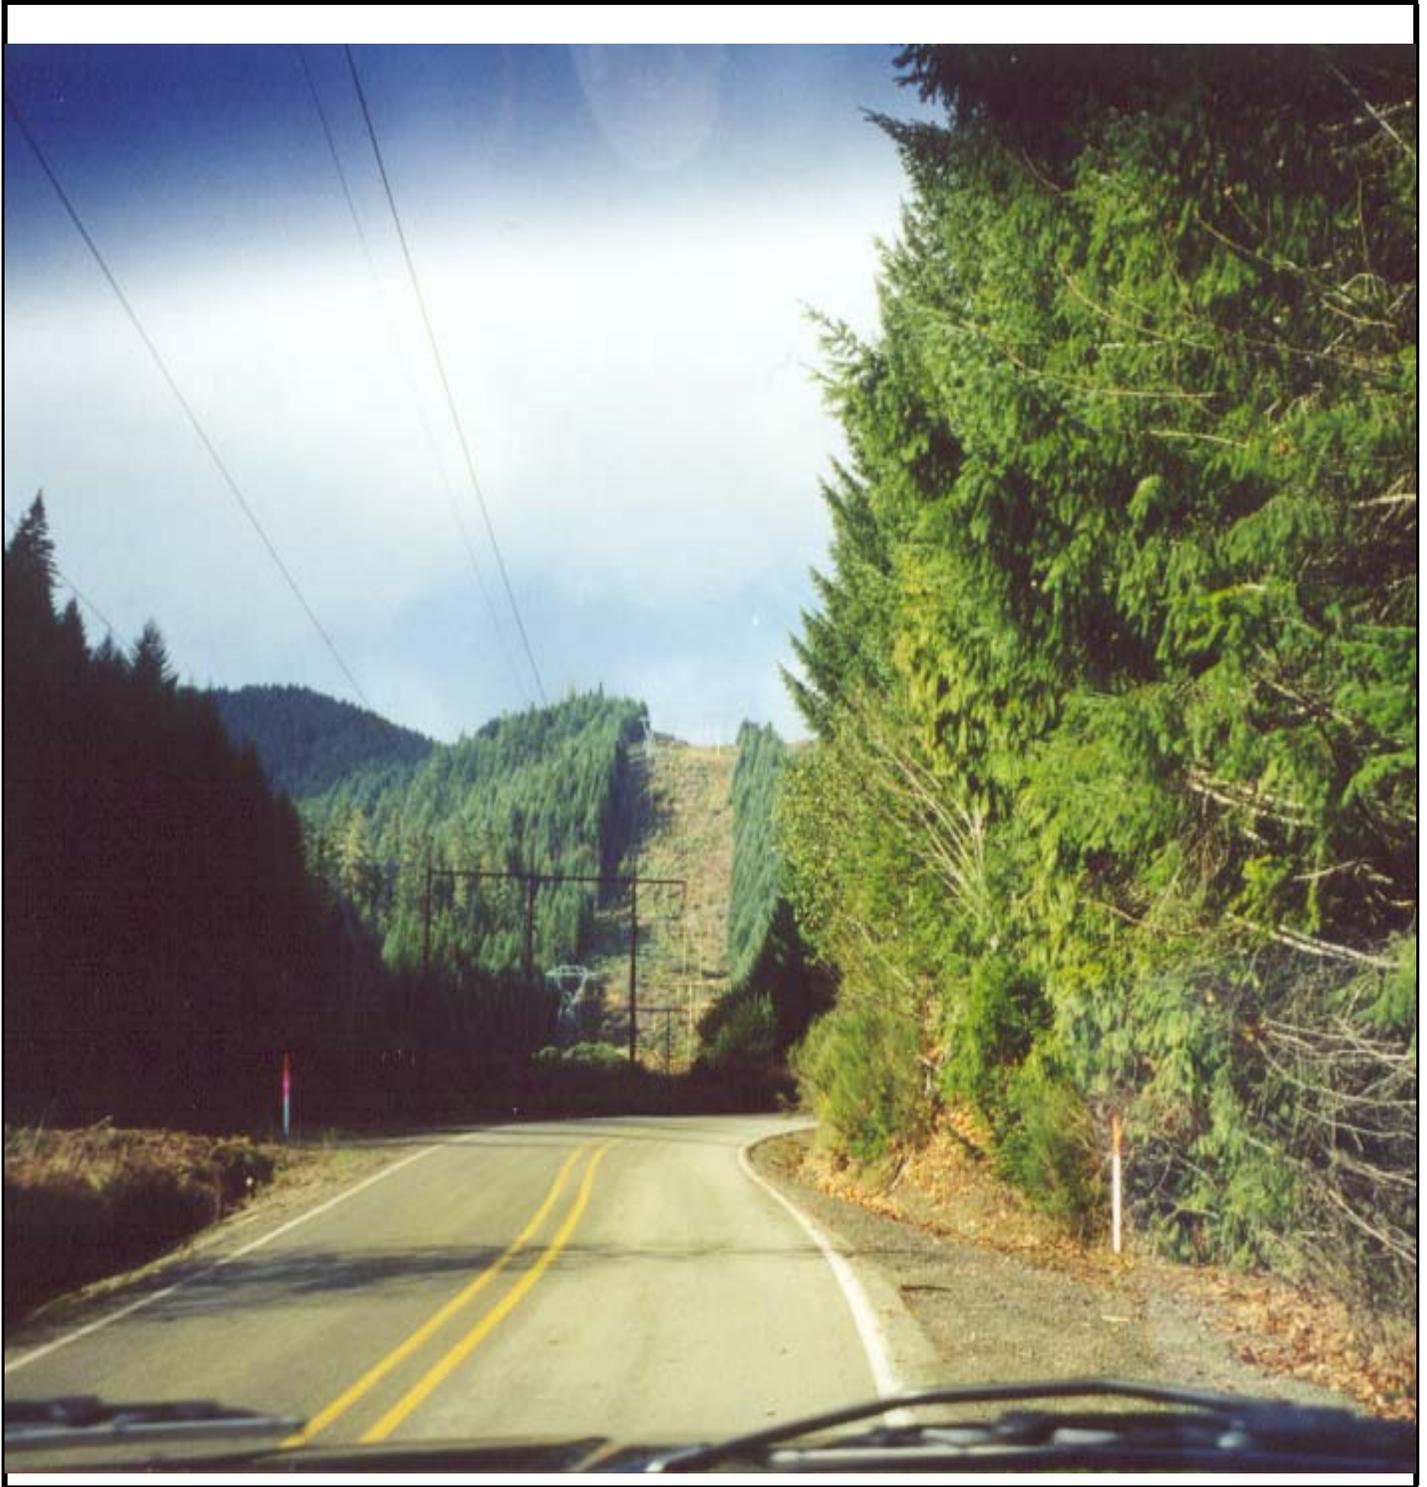
Figure A-3. Rise of BPA powerline up steep 20 percent slope at Mile 13 on CBW Road

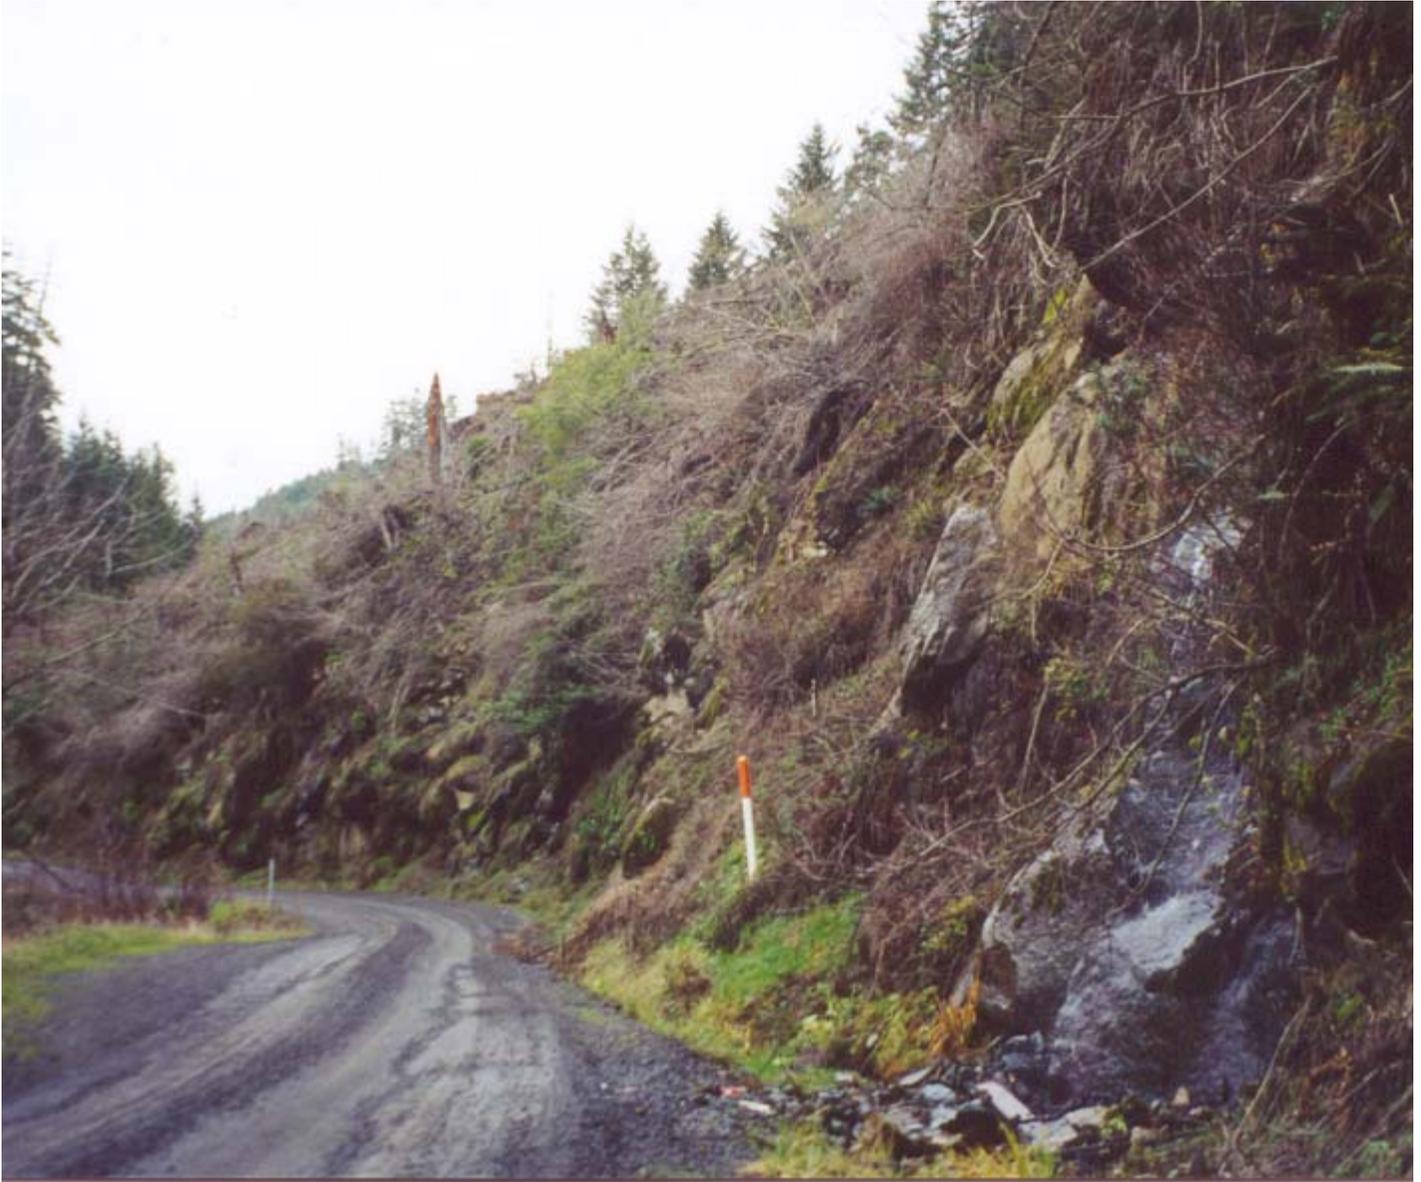
Figure A-4. View along Brewster Canyon at Mile 21 on CBW Road. Left side of road leads down at steep angle to the East Fork of the Coquille River

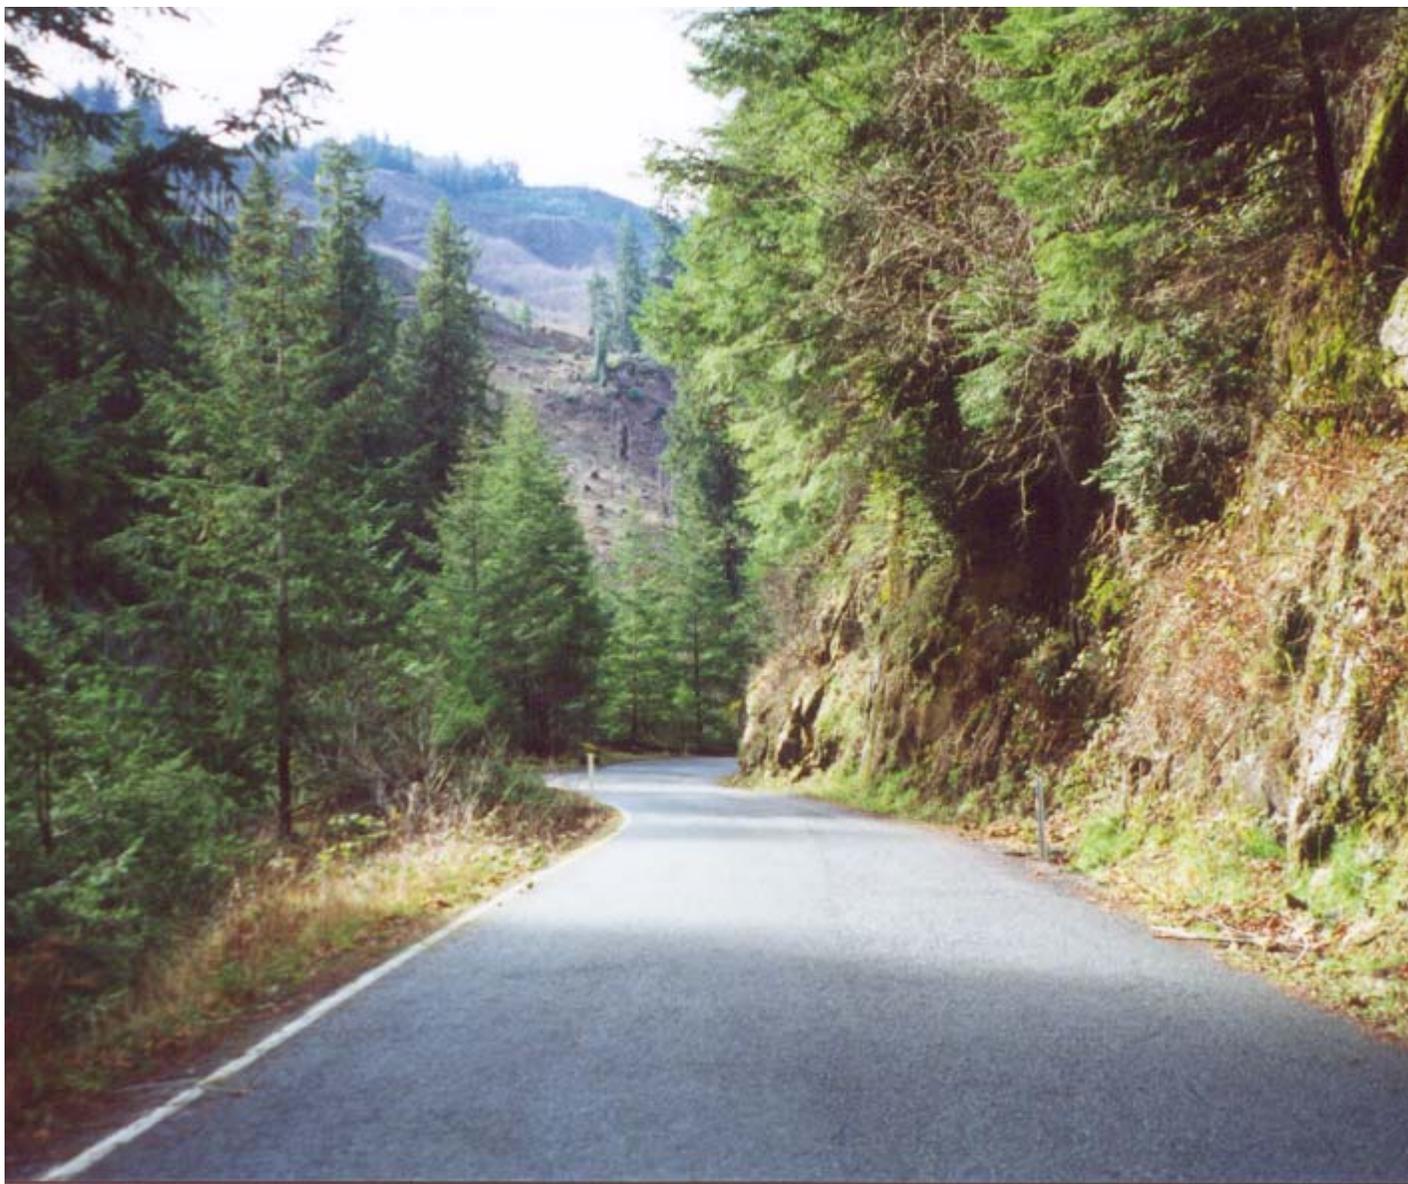
Figure A-5: View Along Brewster Canyon on CBW Road.
