TIOGA CREEK
SEDIMENT BUDGET & DYNAMICS INVESTIGATION

M. J. Scalici
September 1996

reconstructed from original
computer file August 1999

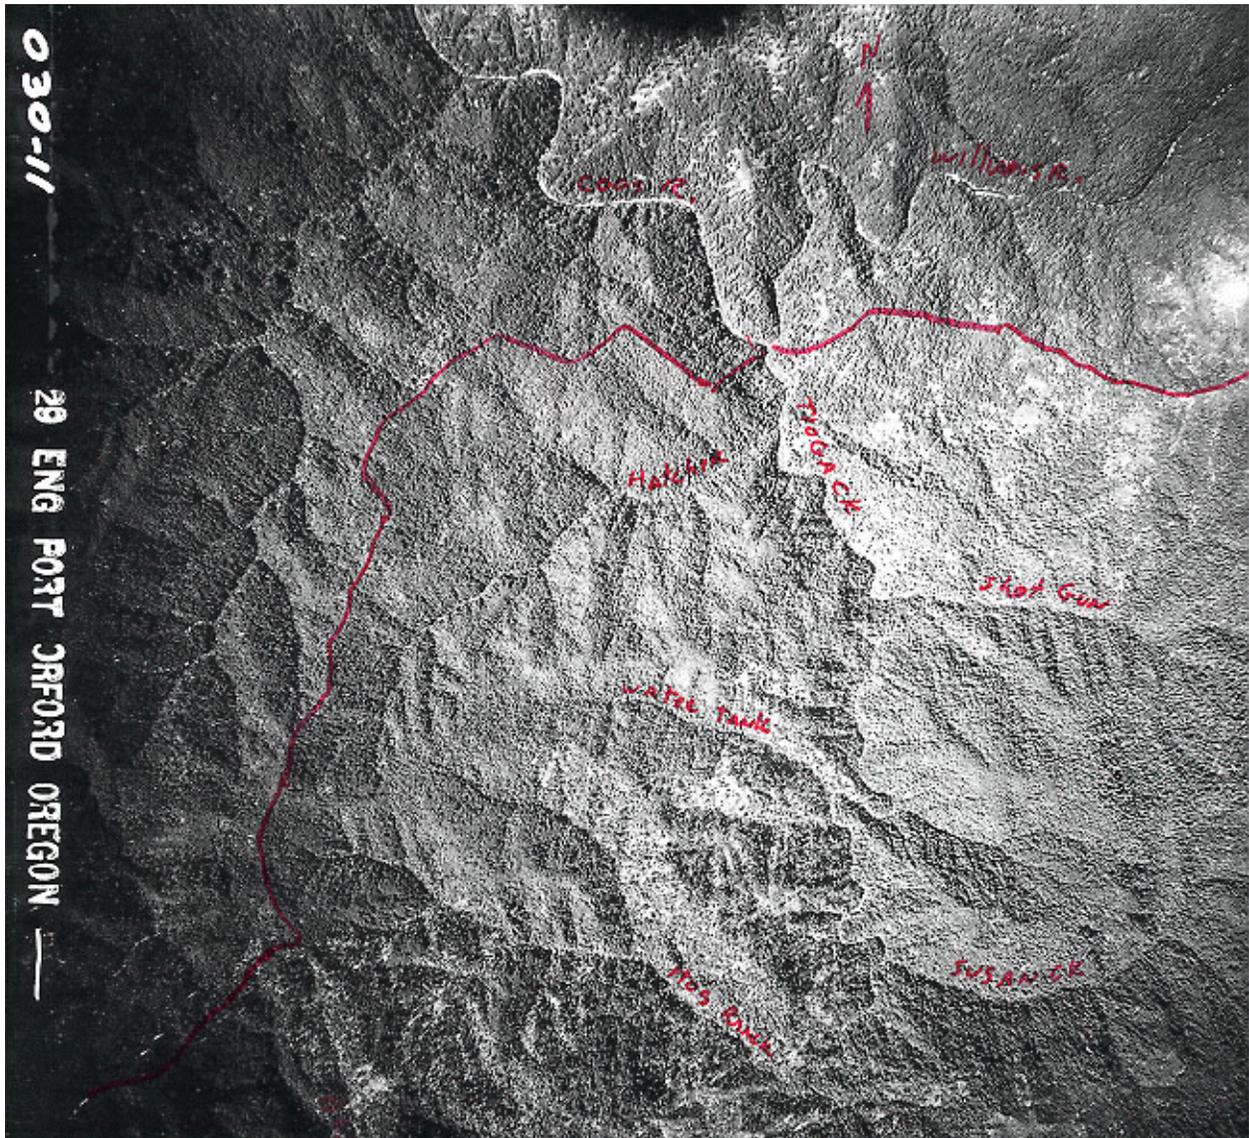
Figure 2: 1943 aerial photograph showing lower Tioga Creek.

Many deeply incised first order tributaries and an intricate mosaic of forest successional patterns were evident in this photo set. The most deeply incised areas were in the north and north-northwest-flowing tributaries of Shotgun Creek; tributaries to the small drainage in the South ½ Sec.20, T 26 S, R 9 W; the NNW-flowing draws draining the steep slopes in the south ½ Sec.7, T 27 S, R 9 W; and the NNW-flowing headwater tributaries of Buck Creek (SE quad Sec.6 and NE quad Sec.7, T 27 S, R 9 W) (See Figure 2).

Early successional vegetation in valley bottoms, indicative of recent debris torrents, were evident in the NNW-flowing Tioga tributary **17R** (East ½ Sec.18, T 27 S, R 9 W); around the **confluence of Upper Tioga Creek and Wilson's Folly Creek** (Sec.8, T 27 S, R 9 W); and the WNW-flowing Tioga tributary **11L** (SE ¼ Sec.1, T 27 S, R 10 W). The NE-flowing Tioga tributary **14R** (Sec.12, T 27 S, R 10 W) apparently possessed mature timber in its valley bottom and showed no evidence of past debris flows or torrents, a situation that would change in the following decade.

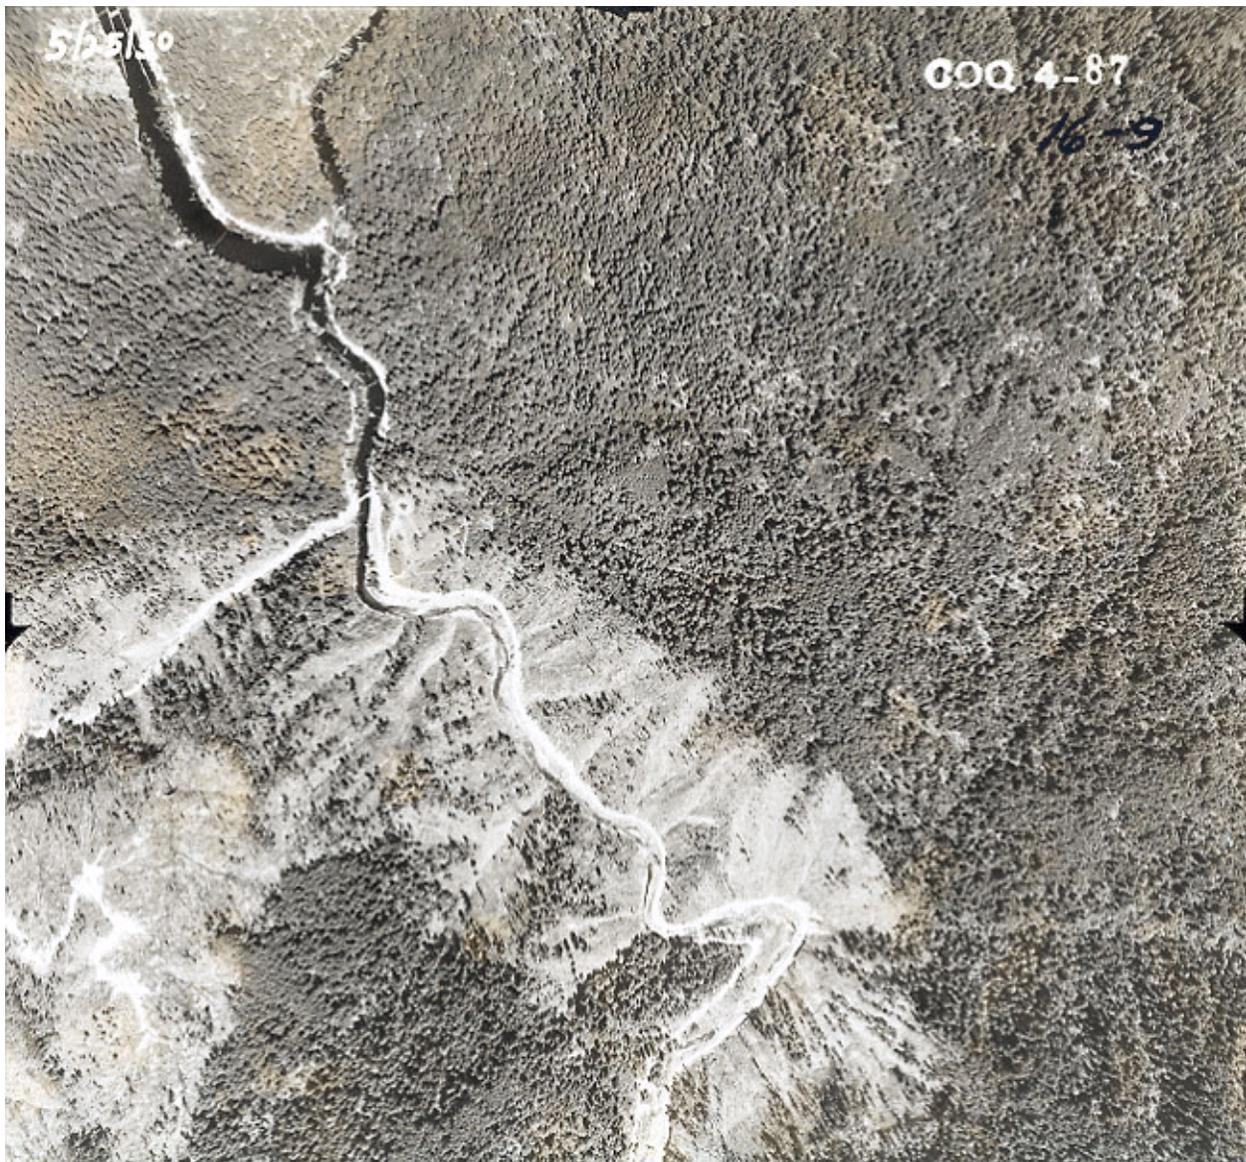
This photo set was taken at a time when intensive logging was on the increase. A road had already been punched up the lower few miles of the Subwatershed from the mouth in 1943 and fresh scarps were clearly visible at the base of the valley wall as a result of the road cut (Figure 3). The **Tioga Splash Dam** was in use, impounding water up to the first major meander about half mile upstream of the mouth (*COQ 4-87, 4-86*). Numerous logs were visible in this impounded reach (*COQ 16-8, 16-9*). Photos 4-90 and 4-91 showed no logging and no fresh slides evident in the **Water Tank Creek** drainage.

Figure 3: The 1950 photo, *COQ 16-9* showing lower Tioga Creek and the Tioga Splash Dam. Logs were skidded down the steep hillslopes above the road and dumped into the impounded lower Tioga Creek. Opening the dam would drain the water and mobilize the logs.
