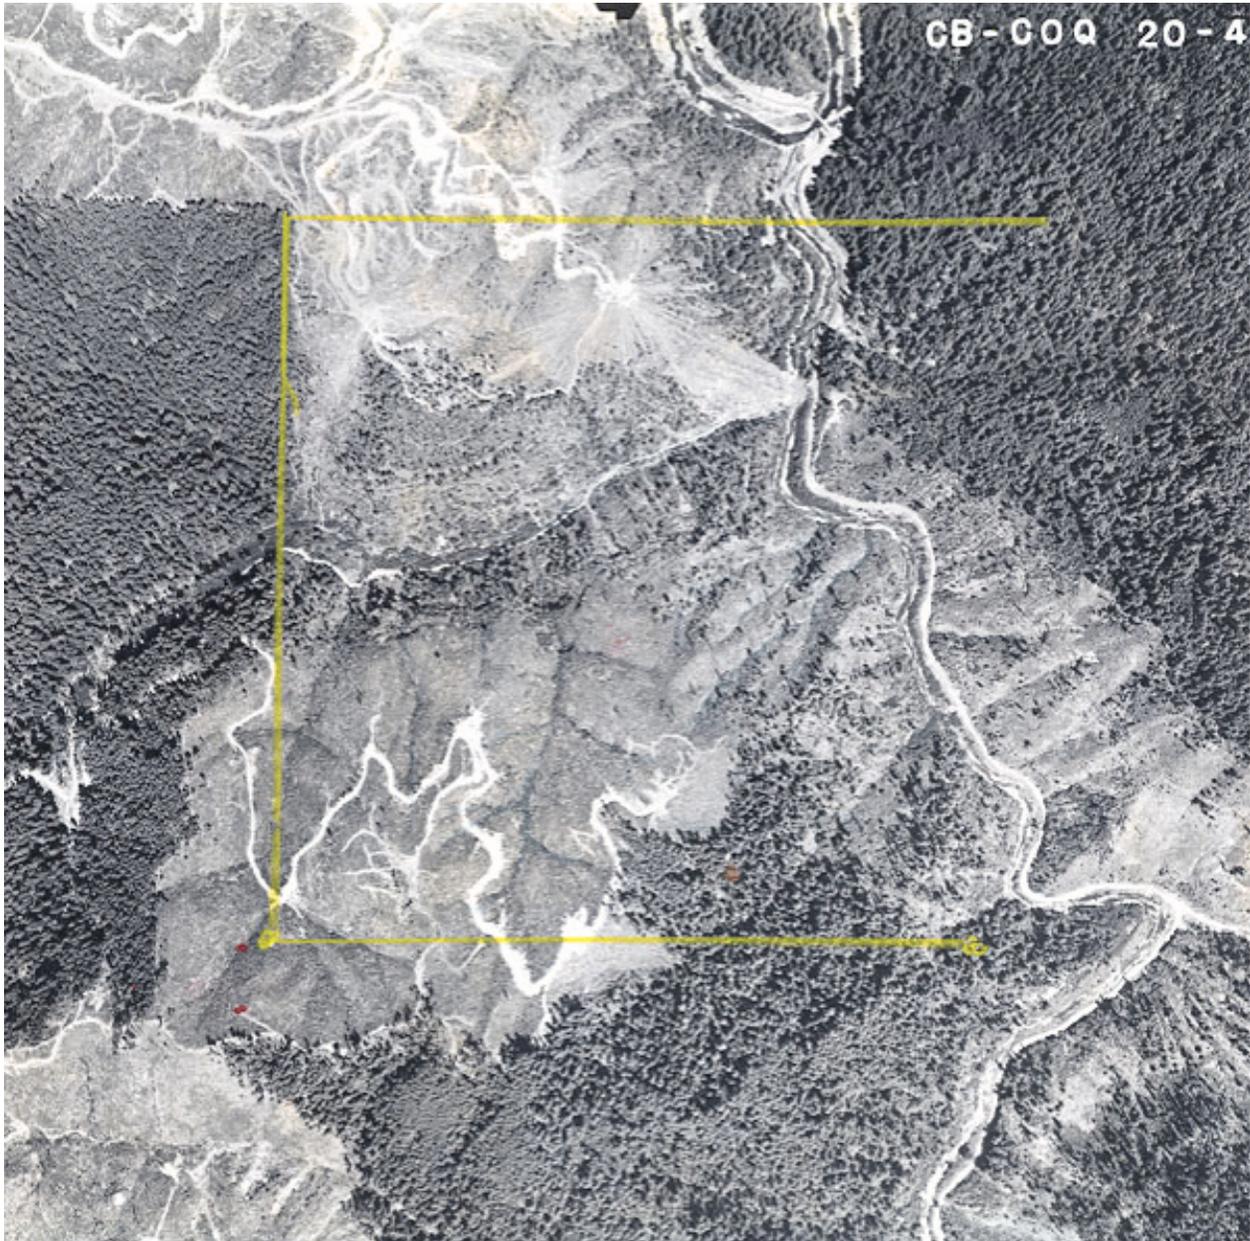
The mainline road was already established up the Tioga Creek valley to the confluence of the South Fork of Tioga Creek and Tioga Tributary 18L and part-way up 18L. The splash dam was no longer in use and in the **lower mile of Tioga Creek**, a great deal of woody debris and sidecast boulders were evident in the channel, and very little riparian vegetation remained (Photos 20-43--20-44) (Figure 4). The depositional patterns in this reach showed diagonal bars and had a high width-depth ratio indicating a channel whose sediment supply exceeded the competency of the stream to transport it. A huge pile of debris filled in the main channel immediately below Hatcher Creek (Photos 20-43--20-44). Most of the hillslopes of lower **Hatcher Creek** were actively being *logged* at this time (Photos 20-43--20-44).

Figure 4: The 1959 photo, CB-COQ 20-43 showing the lower mile of Tioga Creek. Note the extensive diagonal bars in lower Tioga Creek and the recent intensive logging on the hillslopes of Hatcher Creek.

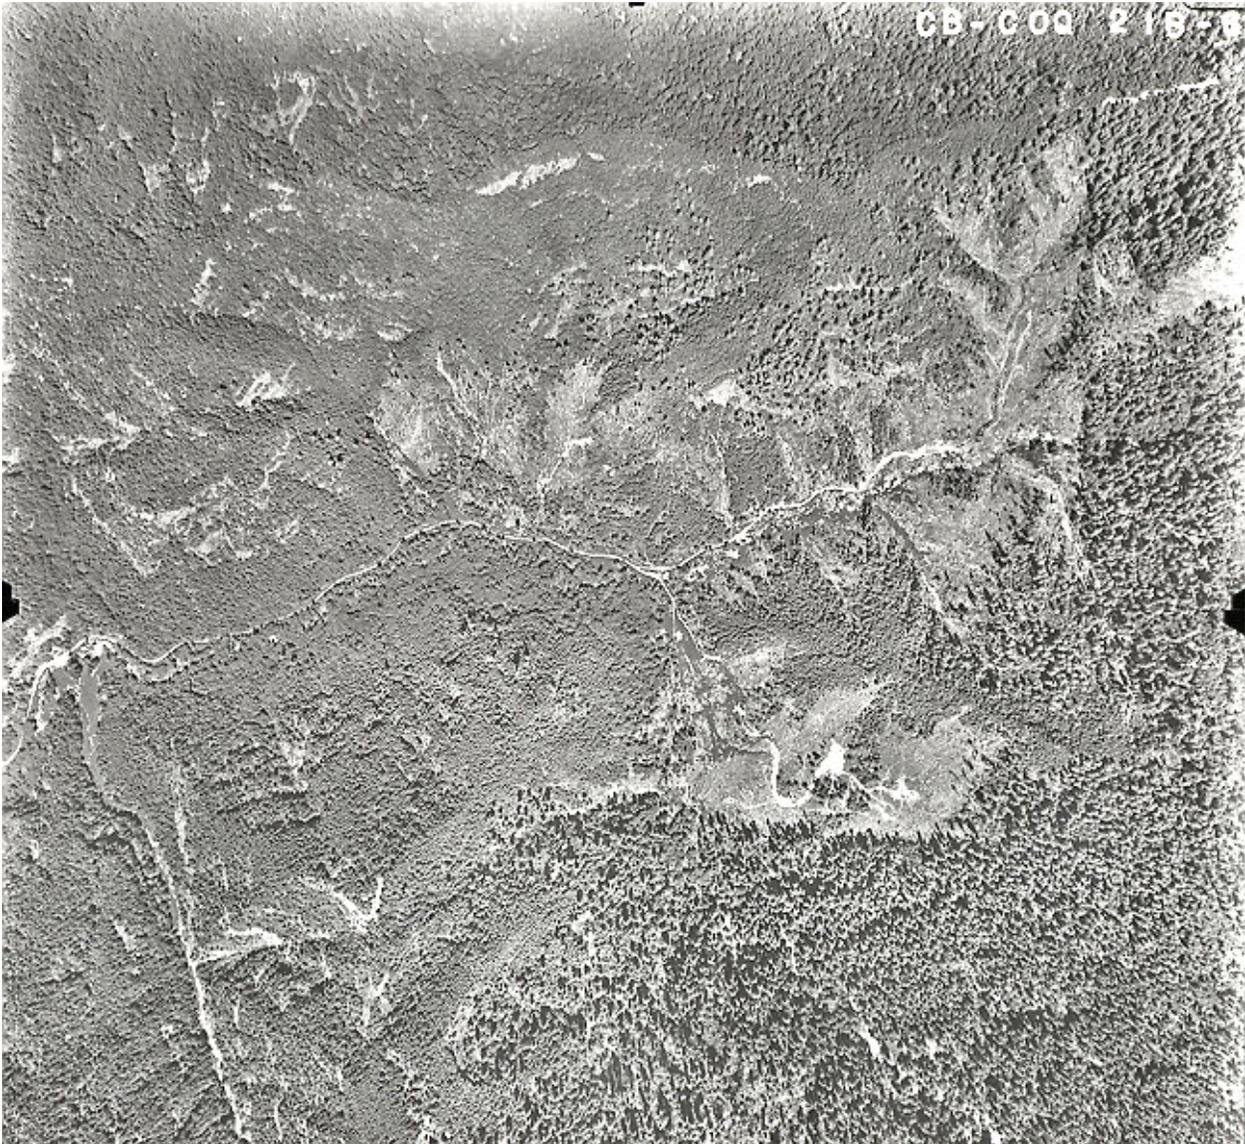
Figure 5: The 1959 photo, 21B-6 showing Tioga Tributary 17R which showed evidence of a recent (< 5 years) riparian stand-replacement disturbance. Most of its length was unvegetated and the lower end had a young, even-aged stand of red alder.

Tioga Tributary 17R showed evidence of a recent riparian *stand-replacement disturbance* (Photos 21B-5--21B-6). Most of its length was unvegetated and the lower end had a young, even-aged stand of red alder (Figure 5). The Tioga reach between Tributaries 18L and 15R (Mi.13.5-11.5), appeared thickly forested with mature trees, indicative of a relatively stable channel- a condition that would change in the years to come. A *debris flow/ torrent* apparently occurred on the lower end of Tributary 17R. The lower 3,940 ft of this tributary showed recent scour and the lower 800 ft, where the valley broadened from 100 to 260 ft in width was uniformly vegetated with early successional alder. Two small clusters of mature conifers were spared the torrent, but a debris jam formed at the confluence with Tioga Creek (mi. 12.4). Although a road ran along the headwaters of 17R and the freshly eroded valley bottom could be traced to within a few hundred feet of the headwaters, there was no evidence from the photo that a mass wasting event originated from the road.

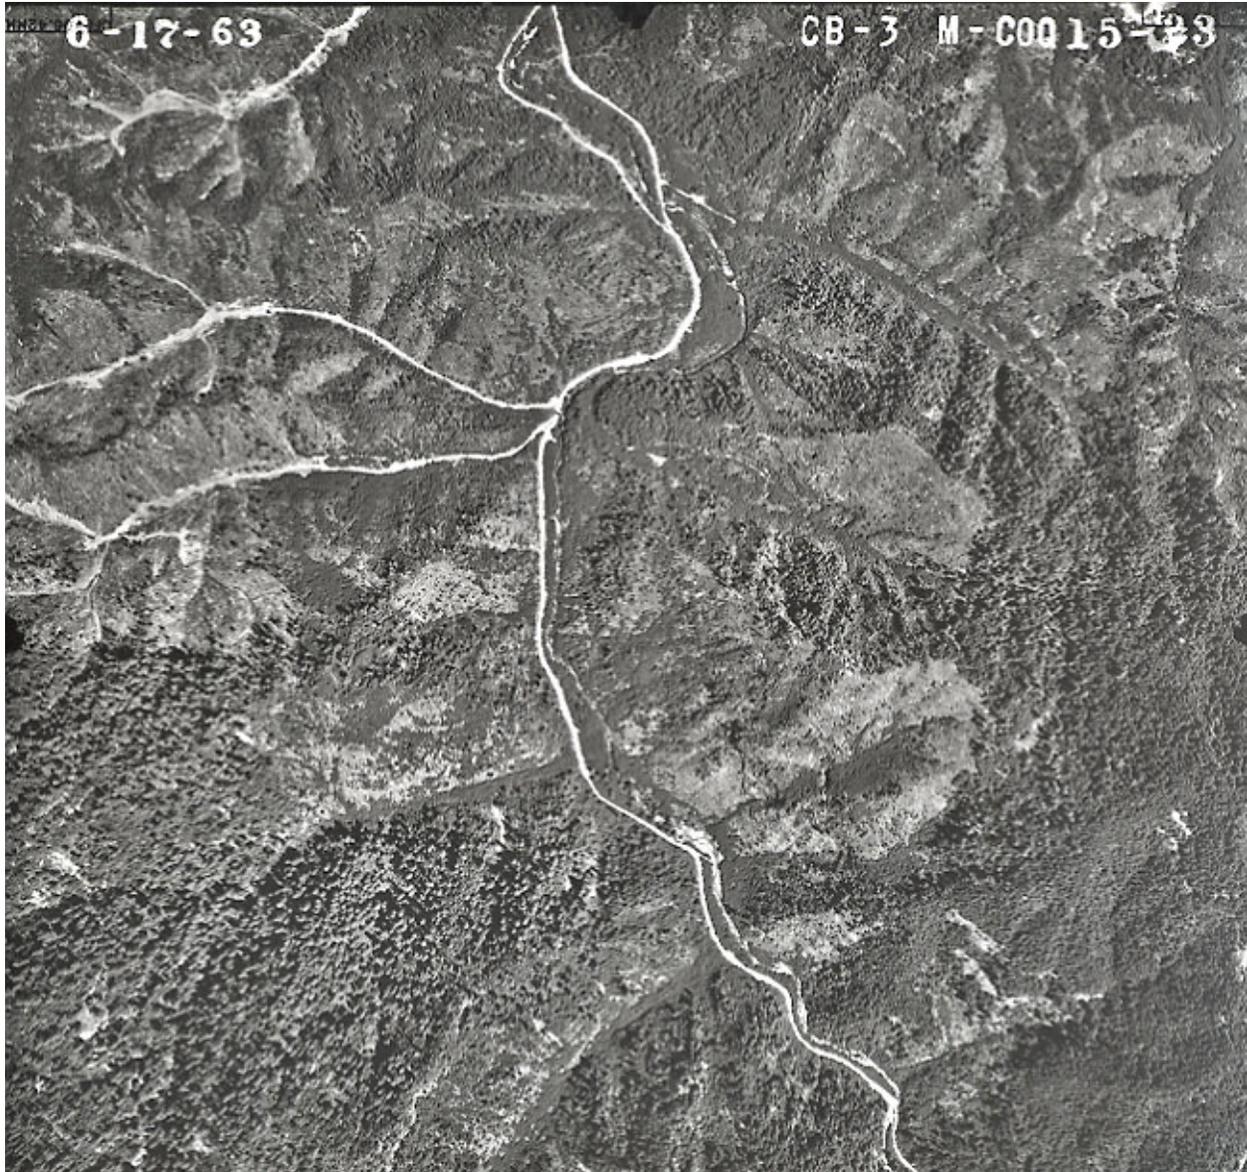
Tioga Tributaries **13R** and **14R** and the Tioga Creek reach in this vicinity (**Mi.11.5-10.5**) showed young, even-aged stands of red alder in the valley bottoms (Figure 6), evidence of a recent (<8 years) stand-replacement disturbance events (**15-22--15-23**). These events did not appear to be related to land use activities. Road networks and logging had clearly expanded in the 8 years since the last aerial photograph, most notably up Tioga Tributaries **10R** and **12R** and throughout much of the central part of the Subwatershed (Sec. 36, T 26 S, R 10 W, Sec. 31, T 26 S, R 9 W) seen in photos **15-22--15-27**. Photos **19-18** and **20-15--20-16** show that logging was also occurring in the flat headwaters in the southeast corner of the Subwatershed (Sec. 15 & 23, T 27 S, R 9 W). Little evidence of failures was visible at this time.

Figure 6: The 1963 photo, **15-23** Tioga Creek around mi. 11.5 to 10.5. Note the young, even-aged stands in the valley bottoms of Tributaries **13R** and **14R** indicative of a recent riparian stand replacement event. Note the intensive logging in Tributaries **10R** and **12R** where logs were being skidded down the hillslopes to the roads that had been cut in the valley bottoms.
