Water and Soils

Fiscal Year 2000 Summary

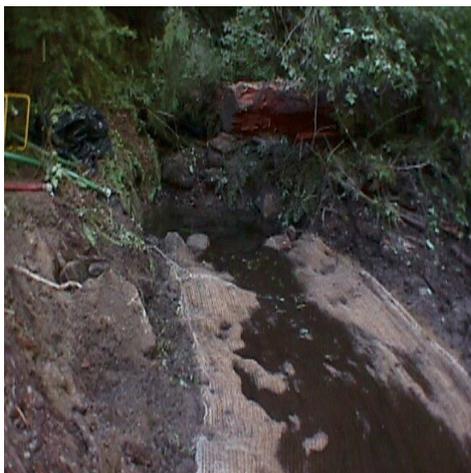
Several new types of erosion control methods were tested on projects this year. The first was an instream biodegradable turbidity filter. Water was routed around culvert removals, along roads that were being decommissioned, to reduce plugging and risk of failure. Then an erosion control blanket was laid in the bottom of the stream channel to capture fine sediment when flowing water was returned to the excavated channel grade. (See left photograph below.) This method proved to be effective to remove fine sediment from the water column at periods of normal low flow. This reduced turbidities in both in quantity and duration.

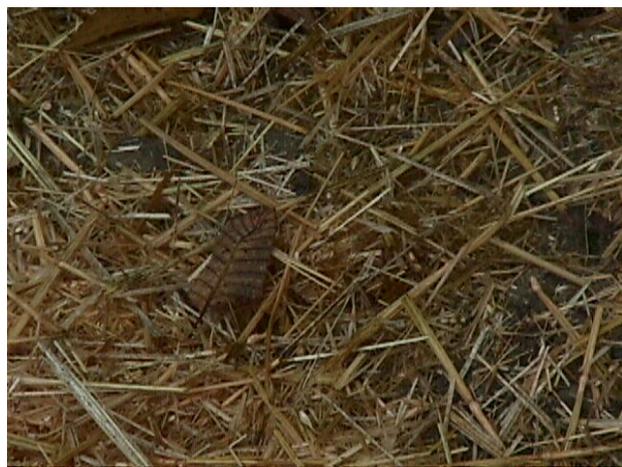
The use of a blown dry straw mulch in place of hydromulch was undertaken this year for the majority of erosion control applications. (See right photograph below.) An overall improvement in surface protection prior to growth of applied grass seed was noted. In some instances seed was applied too late for germination to occur, and the straw mulch was able to provide the required protection.
