CHAPTER 1: EROSION

CHARACTERIZATION

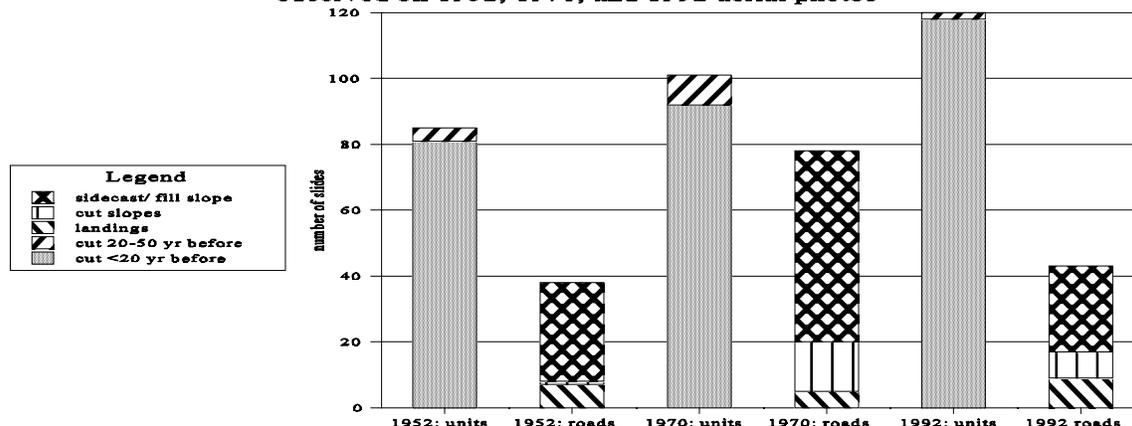
Graph Erod 1

**Slides associated with cutting and roads
observed on 1952, 1970, and 1992 aerial photos**

The logging road construction on steep ground began in the 1950s, and the rate of construction peaked during the 1970s. The highest number of road-associated slides was observed on the 1970 photos. The

percent of large (1,000 to 5,000 square yards) road-associated slides decreased from 1952 to 1970 and again from 1970 to 1992 possibly reflecting improvements in road construction methods (see Tables, E-9, E-10, E-11, and Graph E-2 in the Erosion Processes Appendix).

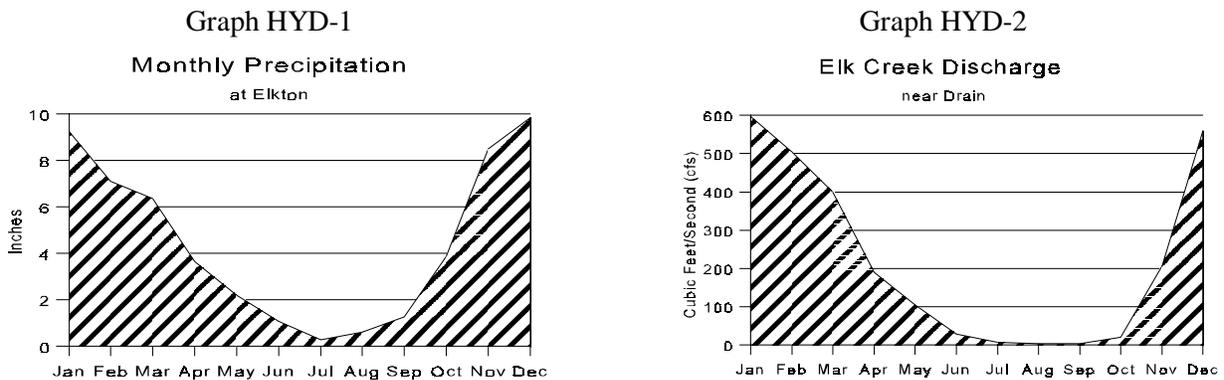
The average annual precipitation ranges from 50 inches in the lower elevations to 70 inches at the higher elevations. This precipitation produces an average runoff of 2.1 cfs/sq. mile/day or approximately 30 inches annually. Graphs HYD-1 and HYD-2 illustrate that the precipitation pattern and the distribution of annual runoff is directly related. Thus, the peak flows are observed during the winter months and low flows in the summer.

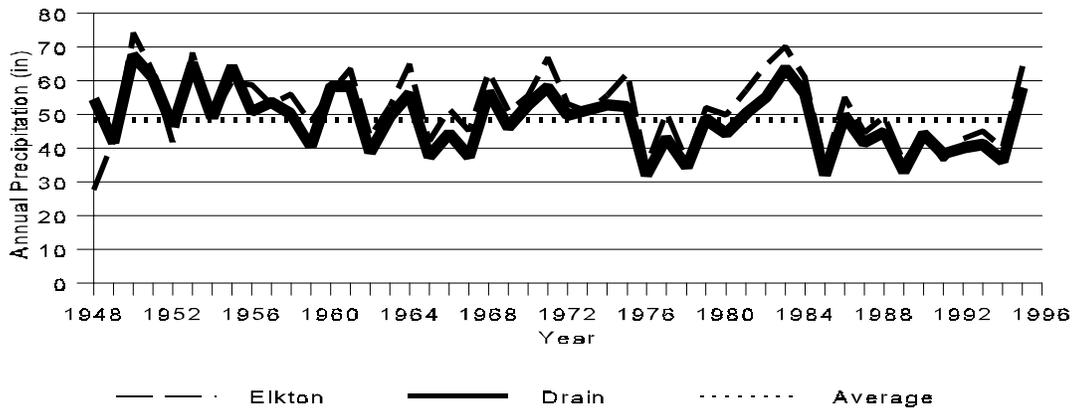
Graph HYD-3: Annual Precipitation at Elkton and Drain

Since the seasonal rainfall pattern is consistent through time, the major factor controlling runoff is the amount of annual rainfall. Graph HYD-3 shows the year to year variation of precipitation. The 1950's and early 1980's were wetter than average, and the mid-1980's to 1994 were below average. Starting in 1995, this pattern has begun to change, with above-average precipitation falling throughout 1996 and into 1997.

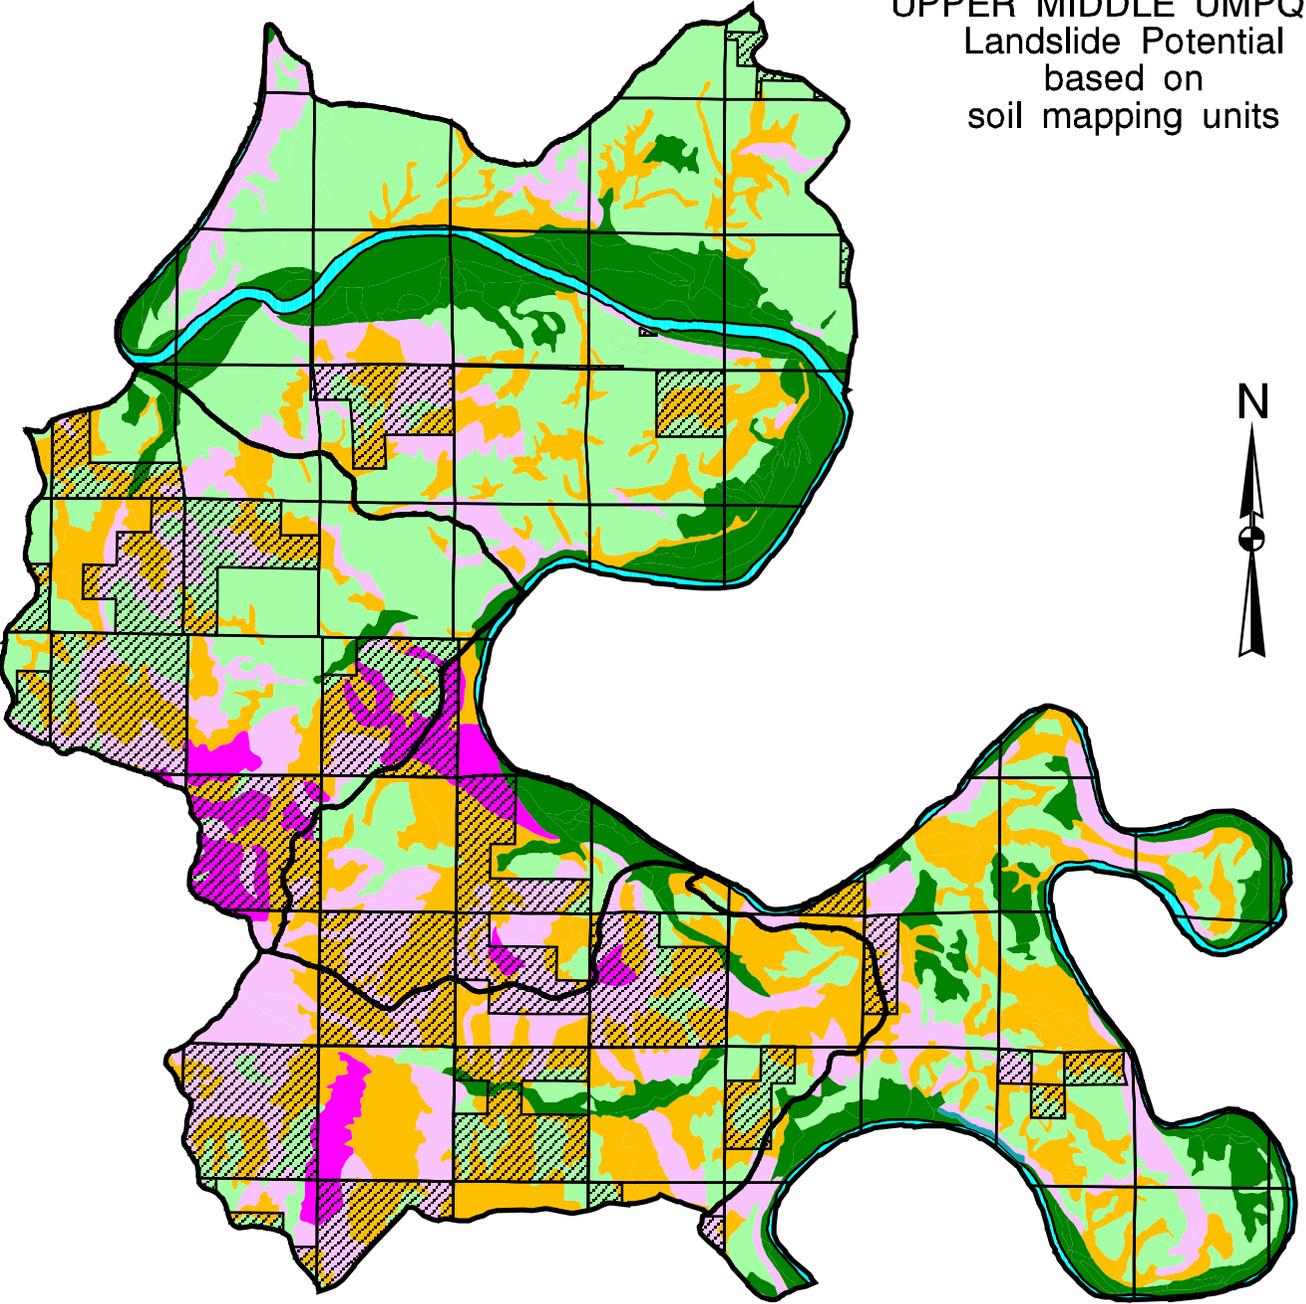
Map Erod-4
 UPPER MIDDLE UMPQUA
 Landslide Potential
 based on
 soil mapping units

Landslide Hazard Potential
 Classification:

- no hazard
- low potential for shallow rapid slides
- mix of low and moderate shallow rapid slide potential
- mix of moderate and high shallow rapid slide potential
- high shallow rapid slide potential
- not apply/ unclassified
- BLM land
- Drainage Boundaries

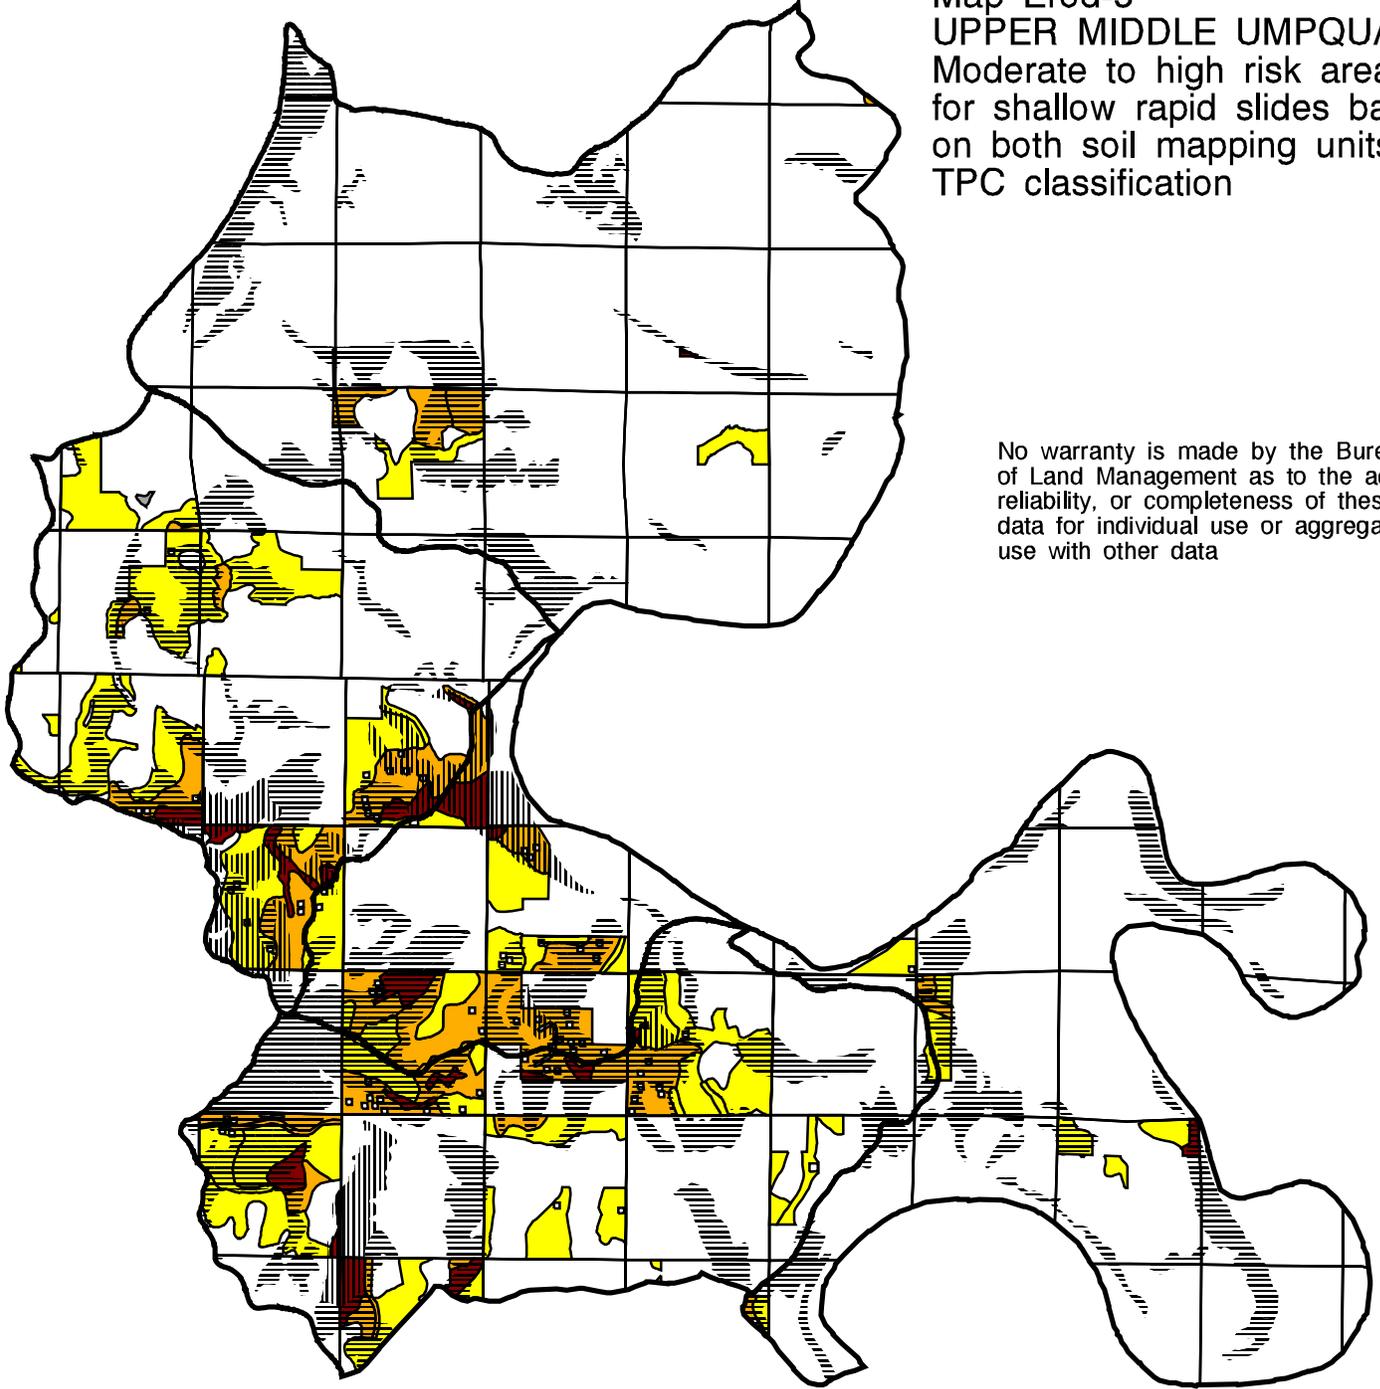
Map Erod-5
 UPPER MIDDLE UMPQUA
 Moderate to high risk areas
 for shallow rapid slides based
 on both soil mapping units and
 TPC classification

Landslide potential based on soil mapping units
 ≡ mix of moderate to high potential for shallow rapid slides
 |||| high potential for shallow rapid slides

Note: Landslide potential, based on soil mapping units, applies to all land inside the watershed analysis area. Fragility classification from TPC applies to BLM land only
