**November 1997**

# Little Butte Creek Watershed Analysis

Version 1.2

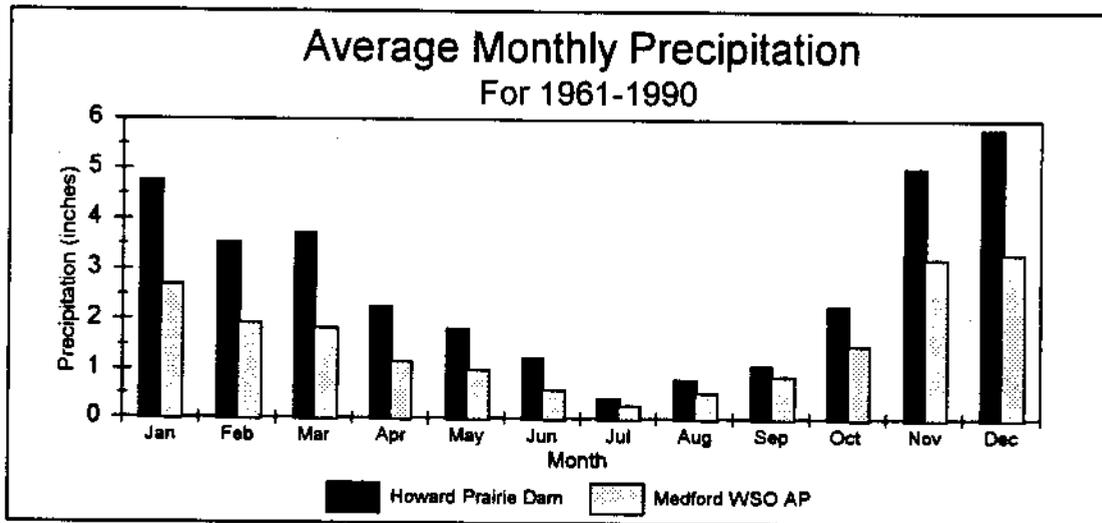
Figure 1. Precipitation at Medford and Howard Prairie Dam NOAA Stations

The National Oceanic and Atmospheric Administration (NOAA) weather station at Howard Prairie Dam (elevation 4,568 ft.), located approximately six miles from the upper reaches of the South Fork Little Butte Creek, provides precipitation data that is representative of the high elevation areas within the Little Butte Creek Watershed. The NOAA weather station located in Medford (elevation 1,300 ft.), approximately six miles south of the mouth of Little Butte Creek, provides precipitation data that is representative of the lower elevation areas within the Little Butte Creek Watershed. Precipitation distributions by monthly average for the Medford and Howard Prairie Dam stations are shown on Figure 1. The majority of precipitation falls during November through March (70 percent of the yearly total). Annual precipitation fluctuates widely from year-to-year in the Little Butte Creek Watershed. The 30-year average (normal) annual precipitation at the Howard Prairie Dam station is 32.78 inches and at the Medford station it is 18.86 inches (NOAA 1996). Figures 2 and 3 show the cumulative surplus/deficit over the past 30 years using a 5-year moving average for both NOAA stations. Below normal precipitation has occurred during 6 of the past 10 years (through water year 1996).

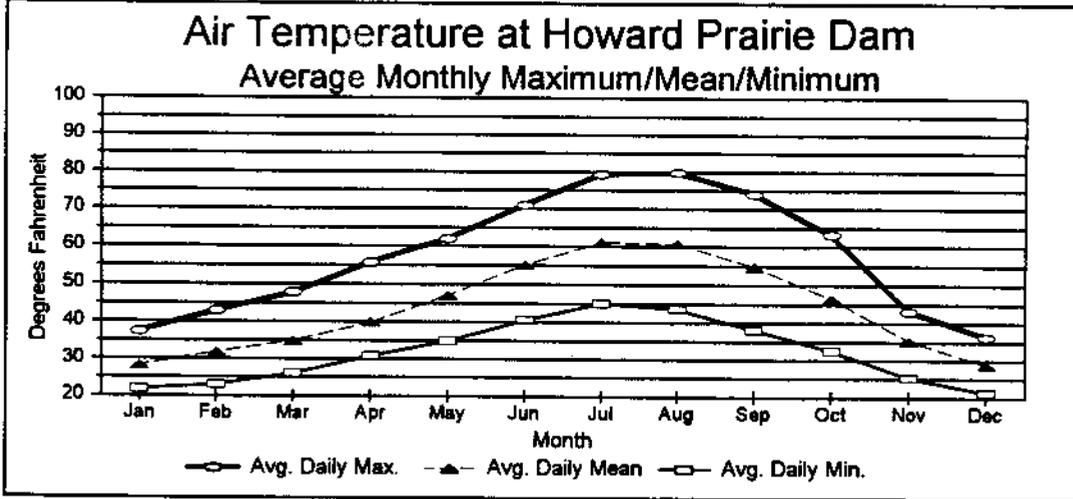
Figure 4. Air Temperature at Howard Prairie Dam NOAA Station

During the summer months, the area is dominated by the Pacific high pressure system, which results in hot, dry summers. Summer rainstorms occur occasionally and are usually of short duration and limited area coverage. The nearest NOAA weather stations with air temperature data are located at Howard Prairie Dam and at the Medford Weather Station. Average monthly maximum, mean, and minimum air temperatures for these two stations are displayed in Figures 4 and 5.

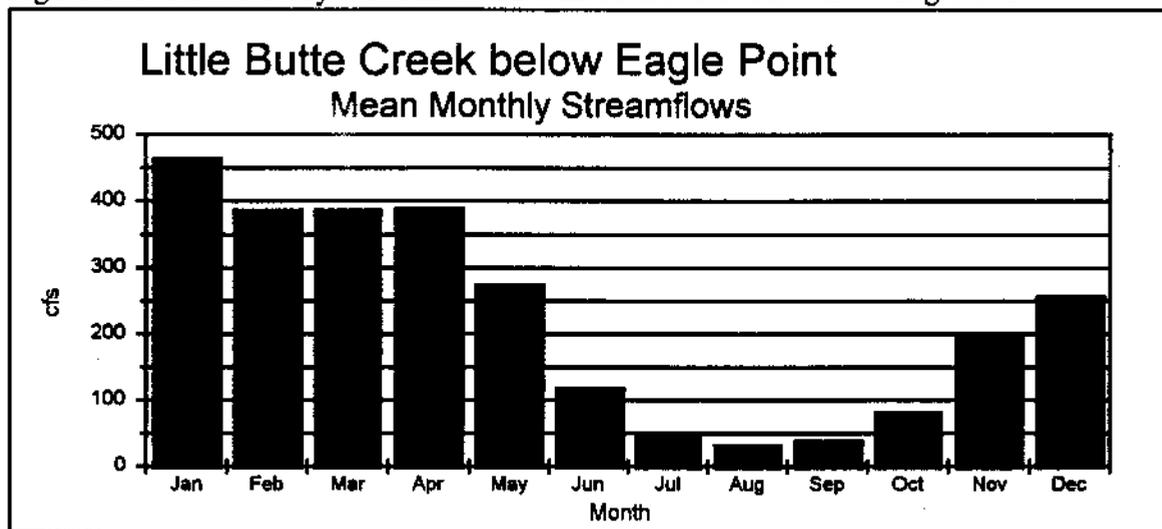
Figure 6. Mean Monthly Streamflows for Little Butte Creek below Eagle Point

The USGS data was used to develop mean monthly hydrographs for Little Butte Creek below Eagle Point (Figure 6), South Fork Little Butte Creek near Lake Creek (Figure 7), and North Fork Little Butte Creek near Lake Creek (Figure 8) (Hydrosphere Data Products 1996).

Streamflow in the Little Butte Creek Watershed fluctuates with seasonal variation of precipitation. Moderate to high flows generally occur from mid-November through May. Streamflows during the months of April and May and part of June are augmented by melting snowpack in the high elevations. Low flows normally coincide with the period of low precipitation from July through September or October for Little Butte Creek (Figure 6) and South Fork Little Butte Creek (Figure 7). Streamflow patterns in North Fork Little Butte Creek are dramatically altered by the water transported to Fish Lake from Four Mile Lake in the Klamath Basin. Winter flows in North Fork Little Butte Creek are moderated by storage in Fish Lake and summer flows are greatly increased by releases from Fish Lake (Figure 8).

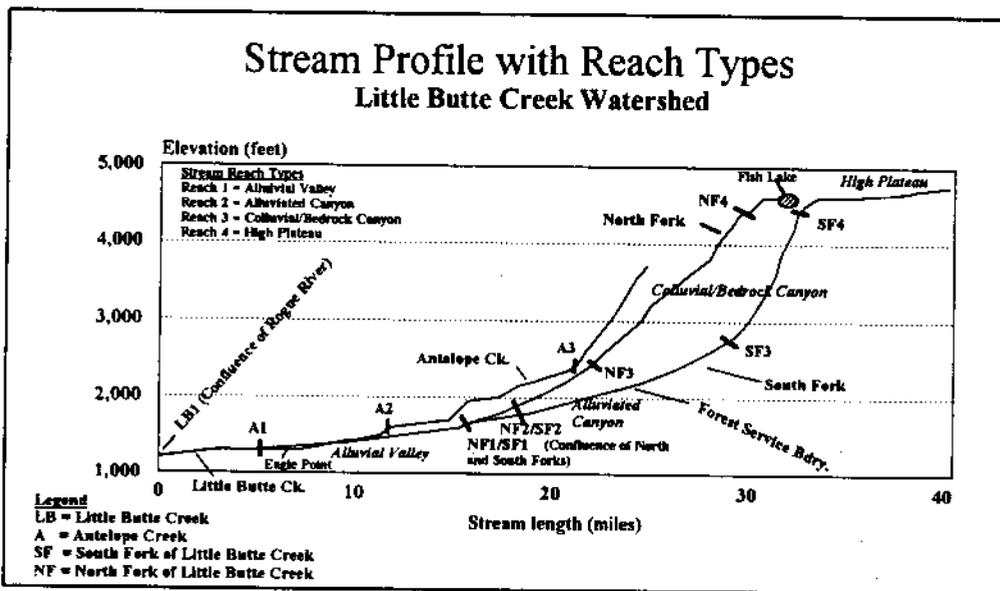
Figure 9. Stream Profile by Reach Types

Streams in the Little Butte Creek Watershed can be divided into four distinct stream reach types that are based on valley types (Figure 9 and Map 15).

Type 1 reaches are in the lower five miles of the North and South Fork Little Butte creeks, in the lower 3 miles of Antelope Creek and the mainstem of Little Butte Creek. Type 1 reaches flow through 19 miles of private land and towns and account for 25 percent of the watershed. Streams in Type 1 reaches have less than 1 percent slope and are C3, C4, or C5 stream types (Rosgen 1994).

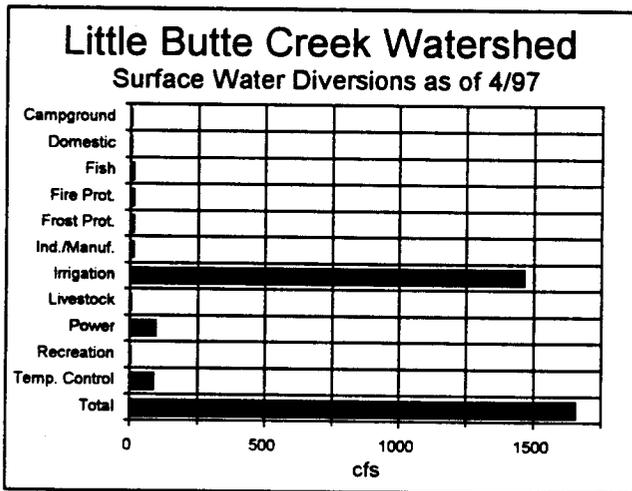
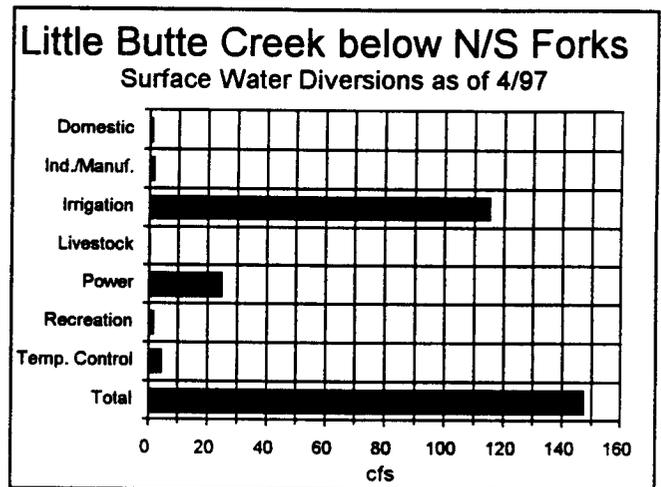
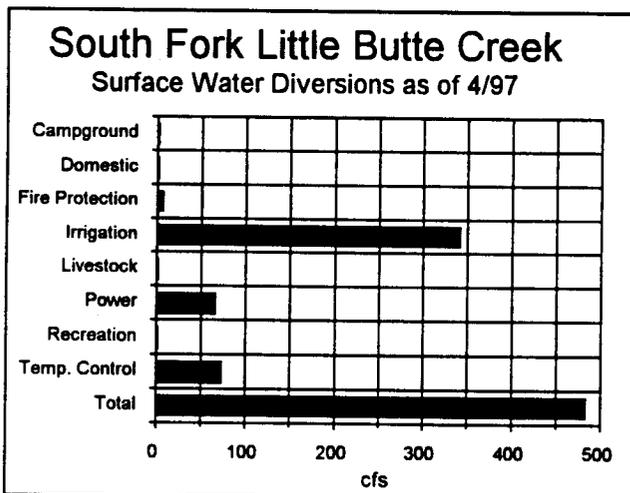
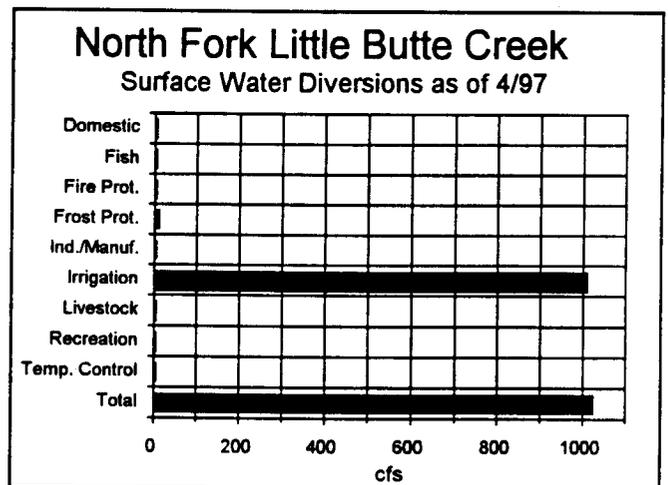
Figure 10. Water Rights for Each Analysis Subwatershed and Little Butte Creek Watershed  
 Source: OWRD 1997

Figure 10 presents water right information obtained from the Oregon Water Resources Department (OWRD 1997) for each of the analysis subwatersheds and the total for the watershed. The majority of water right diversions in the Little Butte Creek Watershed are used for irrigation.

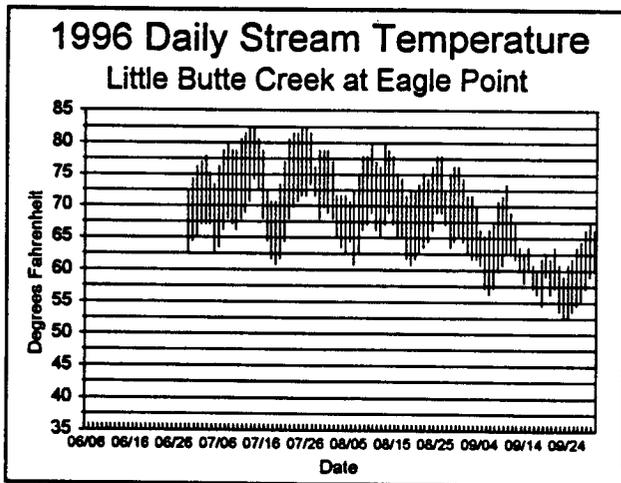
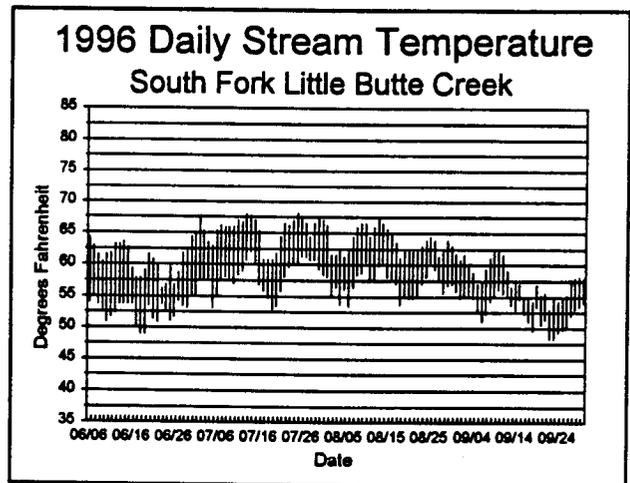
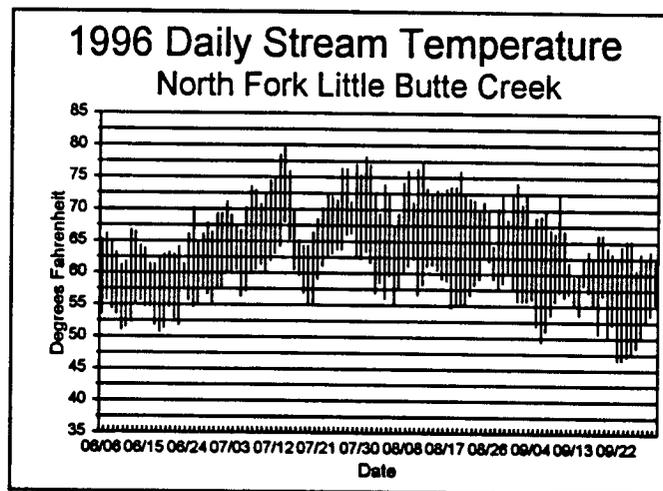
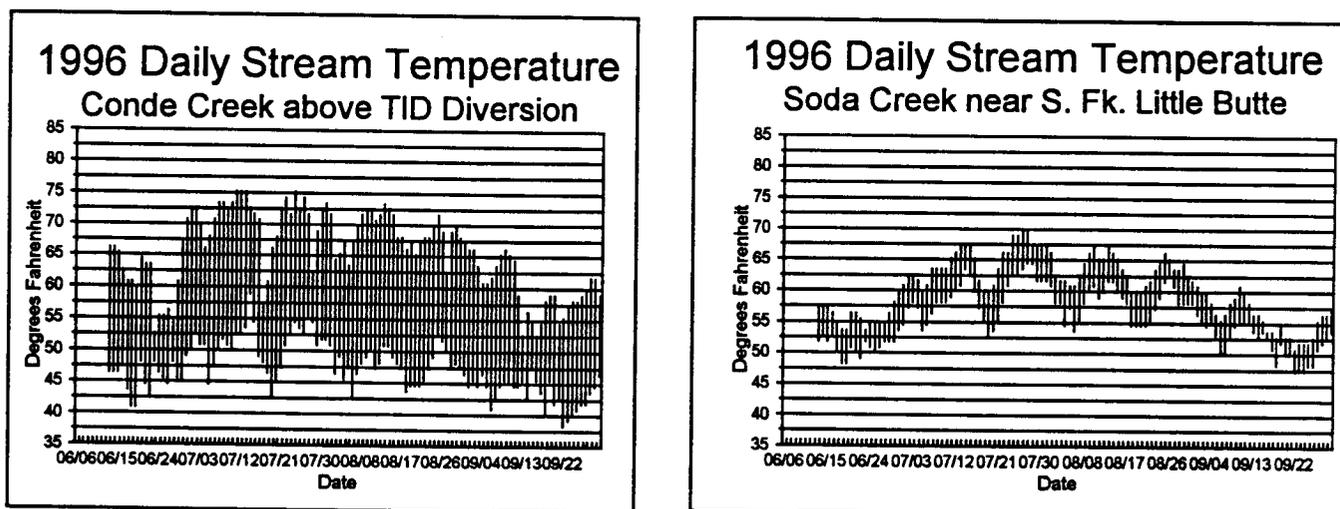
Figure 11. 1996 Daily Stream Temperatures for Five Sites in Little Butte Creek Watershed

since 1993 (Brazier 1994, 1995 and 1996). A summary of 1993 to 1995 seven-day average maximum temperatures for all monitoring sites in Little Butte Creek Watershed is presented in Appendix F.

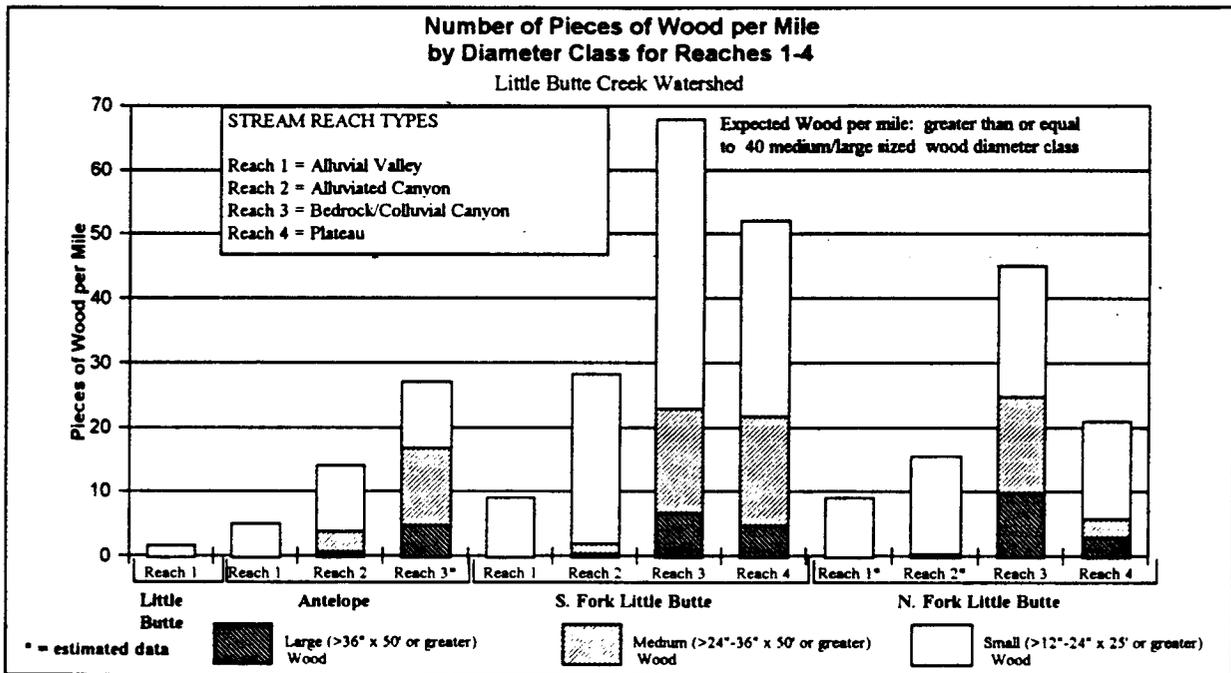
Figure 12. Medium/Large Pieces of Wood Per Mile

Field observation in this watershed has shown a direct correlation between medium/large wood presence and high pool quality. When medium/large sized wood was absent, fewer large-sized fish and reduced overall abundance of fish was observed. Anecdotal information from a long-time resident indicates that pools associated with wood complexes were found at frequent intervals during the 1950s (Brady 1997). These pools purportedly held large salmon and trout. This large wood complex component is almost completely lacking in lower gradient segments today.

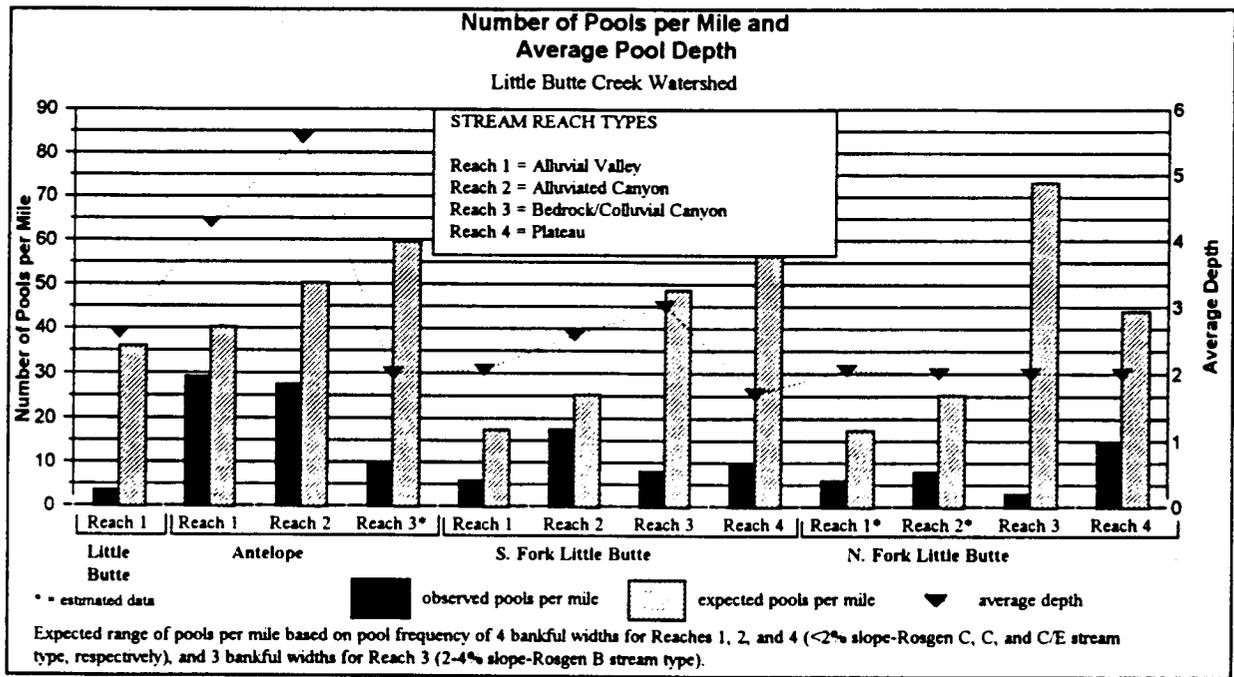
Figure 13. Pools Per Mile and Average Pool Depth

Pools per mile are below the desired range of conditions and indicate habitat degradation (Figure 13). Low quantity and quality (depth and cover) of pools were recorded where large wood has been reduced or eliminated. There is considerable literature documenting the importance of pools for salmonid fish production. Pools in managed stream segments near roads or otherwise accessible to heavy equipment lack complexity due to stream cleanout for flood control and timber and firewood harvest. Large wood removal has resulted in reducing sinuosity and closing side channels caused pool and riffle ratios to skew (Figure 14), increased width-to-depth ratio, and denuded riparian vegetation. Long riffles with few instream features and simplified fish habitat are common throughout the watershed.

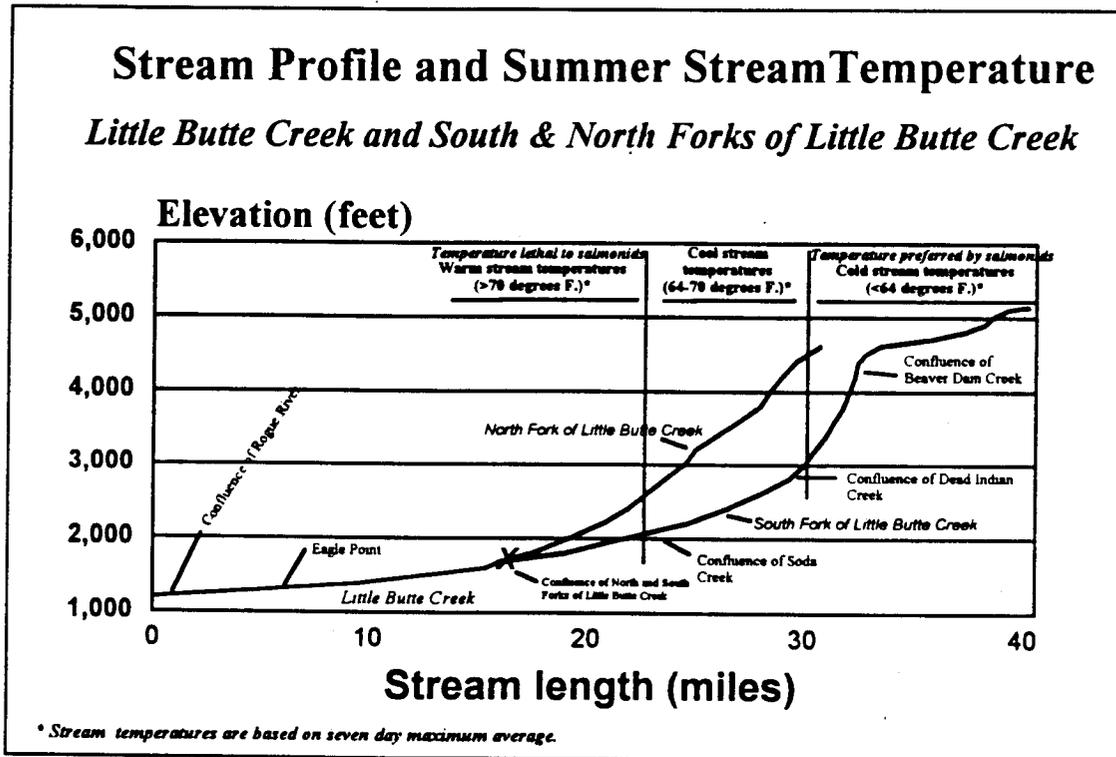
Figure 15. Stream Profile and Temperature Conditions for the North and South Forks of Little Butte Creek

Three irrigation districts have water rights to divert over 1,000 cubic feet per second (CFS)

from the Little Butte Creek Watershed. This does not include water rights for supplemental irrigation from private landowners. Low stream flow resulting from both irrigation withdrawal and drought conditions limit the amount of available fish habitat and increase stream temperatures. Various springs within the creeks may provide a small amount of cool water refuge for fish. North Fork Little Butte Creek is part of the irrigation districts intertransport system, and as such, has an artificial flow regime. Lower flood peaks and pulses, higher summer flows and unseasonally cool stream temperatures in the summer months have altered the stream ecology. The transfer of favorable cooler stream water temperatures below the Fish Lake dam (50-60 degrees Fahrenheit) into a transbasin canal at river mile 3, and the alteration of stream flow from historical levels have degraded the aquatic biotic and fish assemblages in North Fork and Little Butte Creek Watershed.
